Main Plane in facilities (number 1, number 2 and land transportation Roughly built shelter) and elevation surface Plan.

The main improvement contents

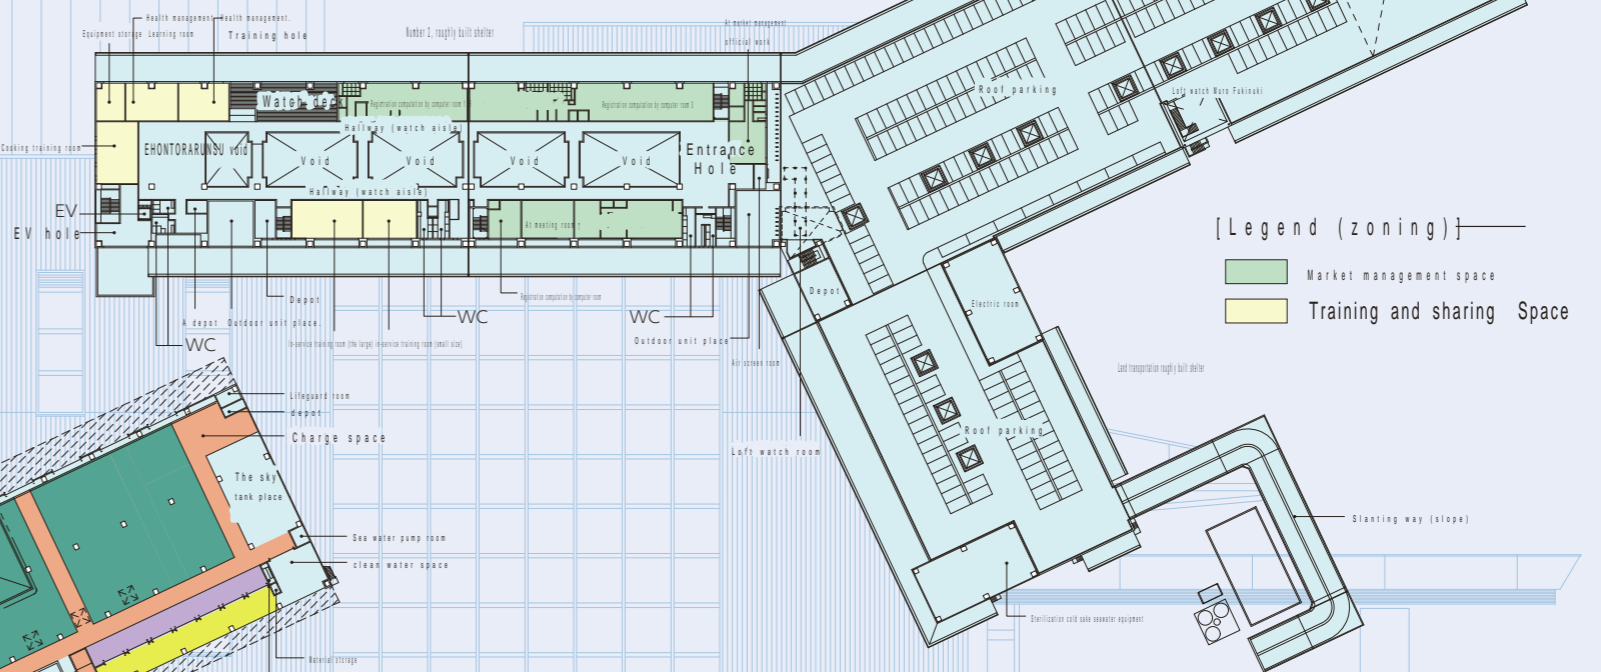
The 2nd floor plan

- Market management space
- Training and sharing Space

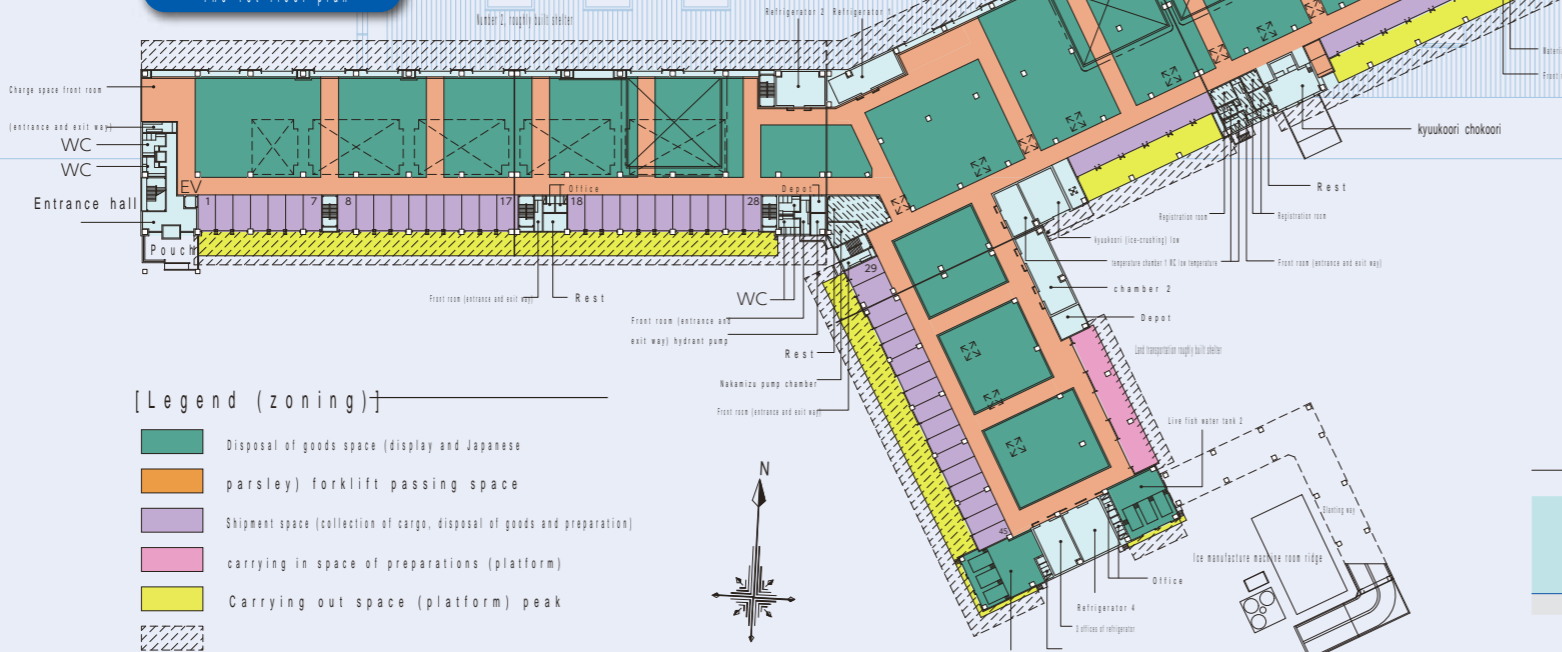
The 1st floor plan

- Disposal of goods space (display and Japanese parsley) forklift passing space
- Shipment space (collection of cargo, disposal of goods and preparation)
- carrying in space of preparations (platform)
- Carrying out space (platform) peak
